EXECUTIVE SUMMARY

INTRODUCTION

TECHNICAL REPORT

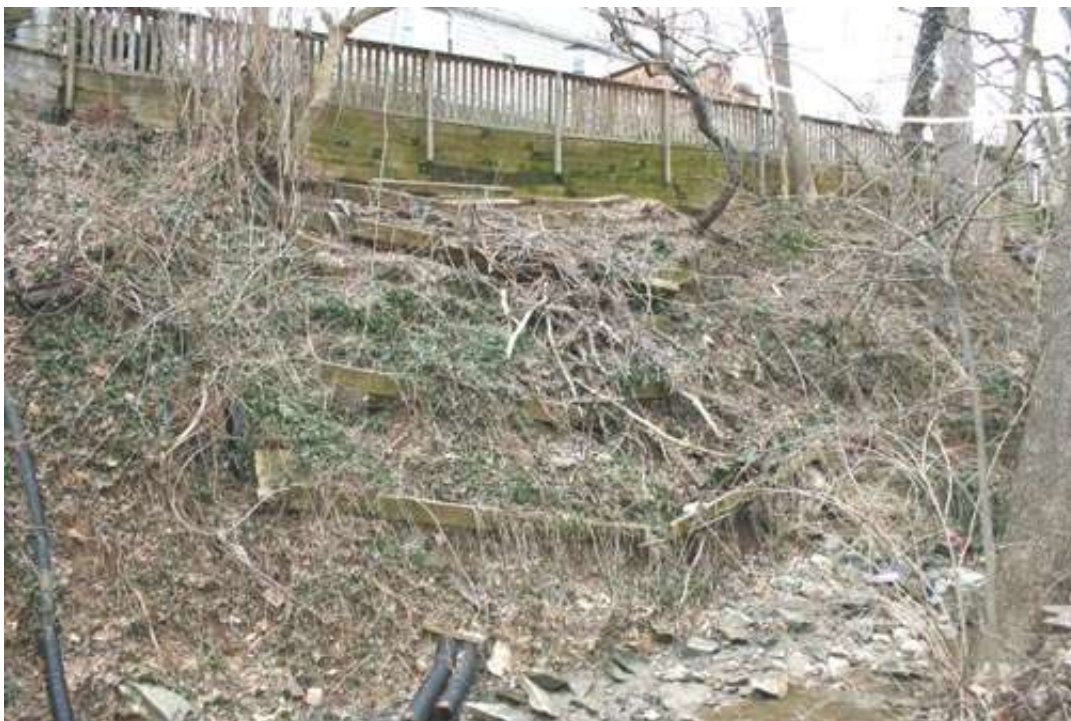
Fig. 30 – Collapsing timber retaining wall along high terrace on right bank.

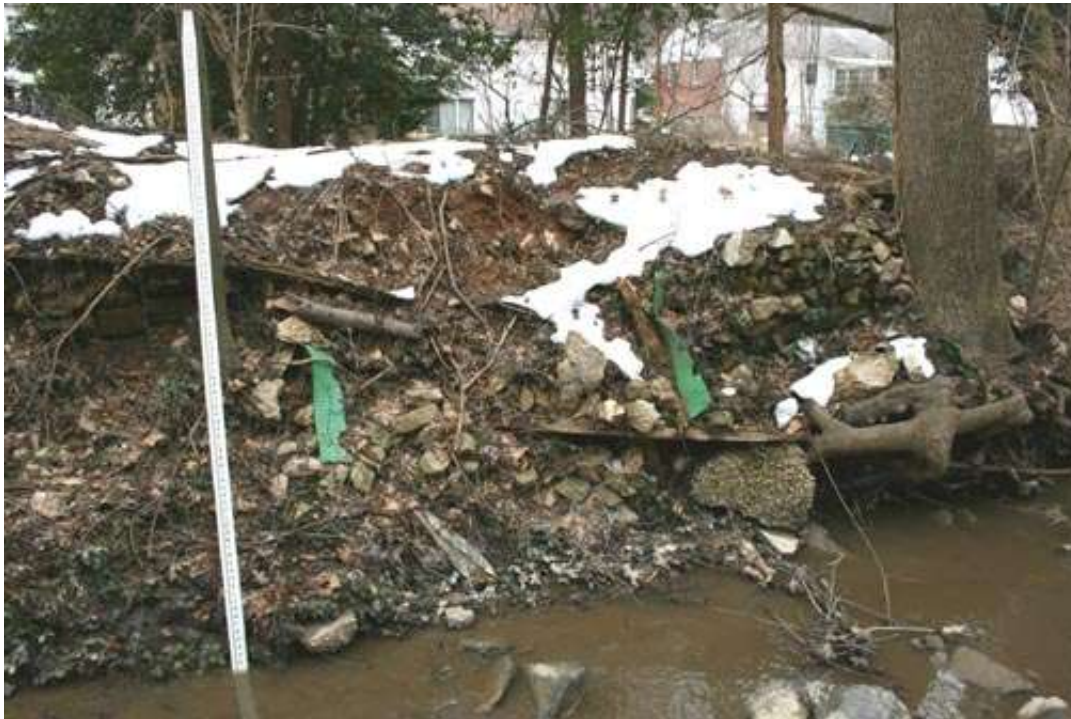
Fig. 31 – Flood berm along left bank.

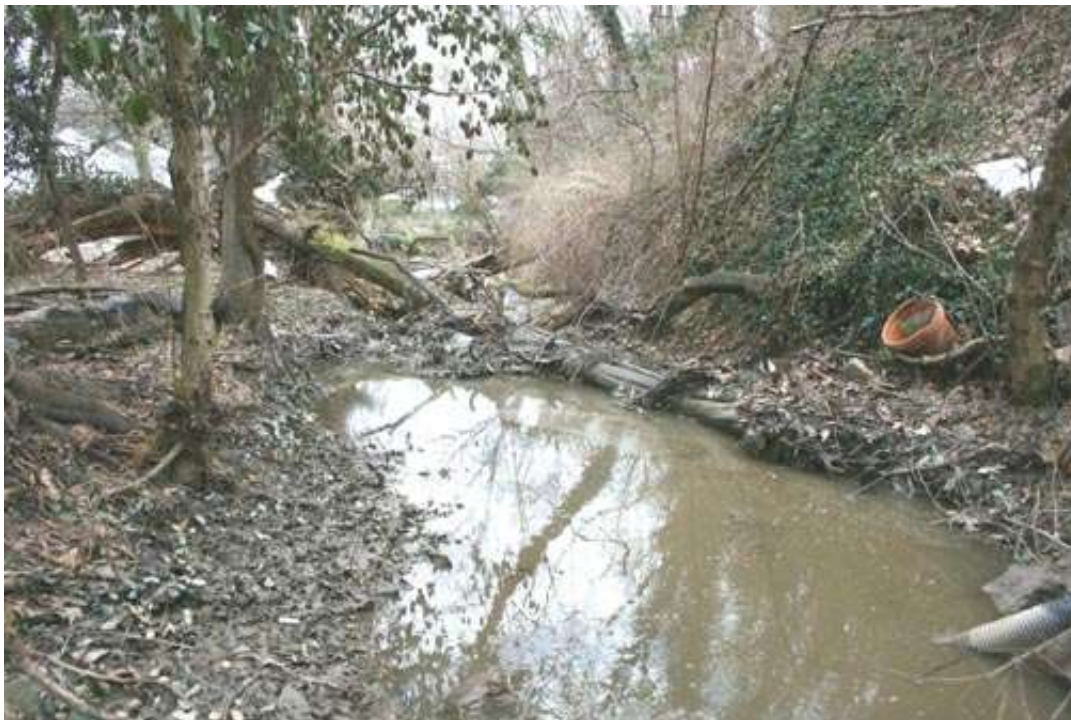
Fig. 32 (view downstream) – Debris jam and aggradation at downstream end of reach.

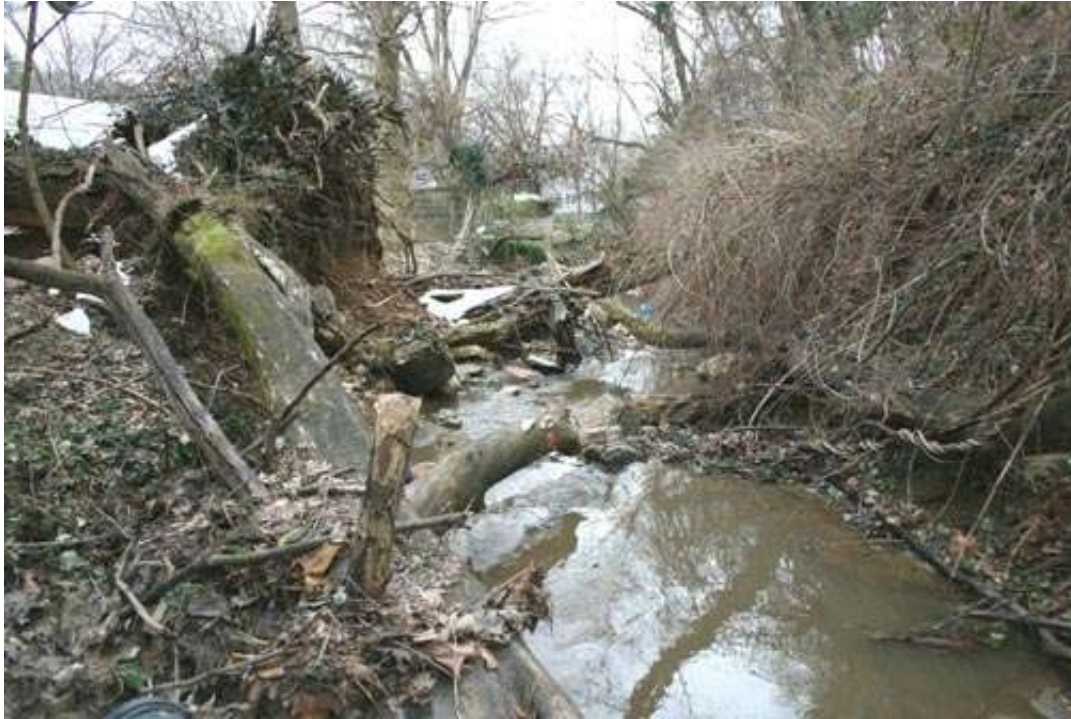
Fig. 33 (view downstream) – Debris jam at upstream end of reach.

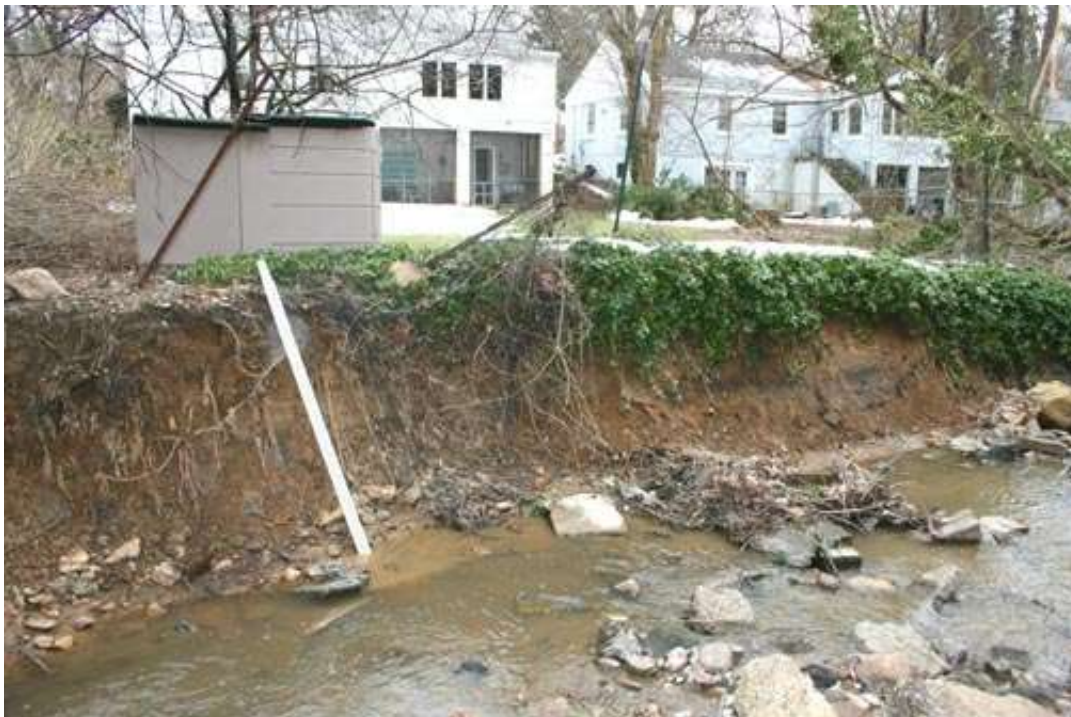
Fig. 34 (view downstream) – Erosion along left bank.

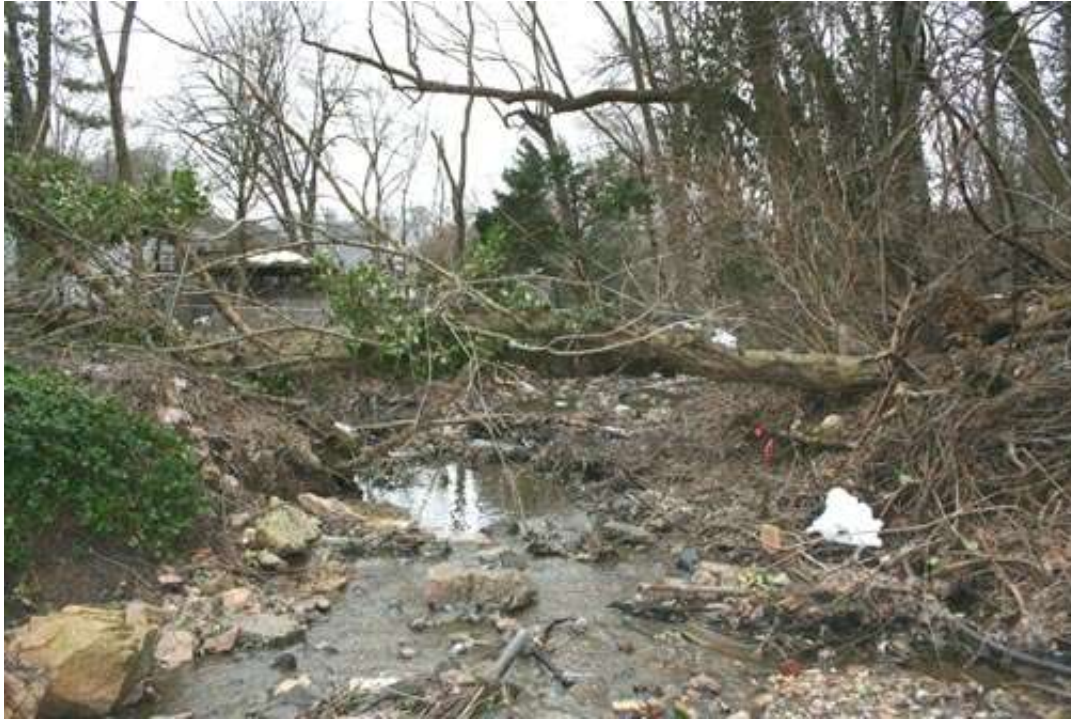
Fig. 35 (view downstream) – Debris jam along upper middle section of reach.

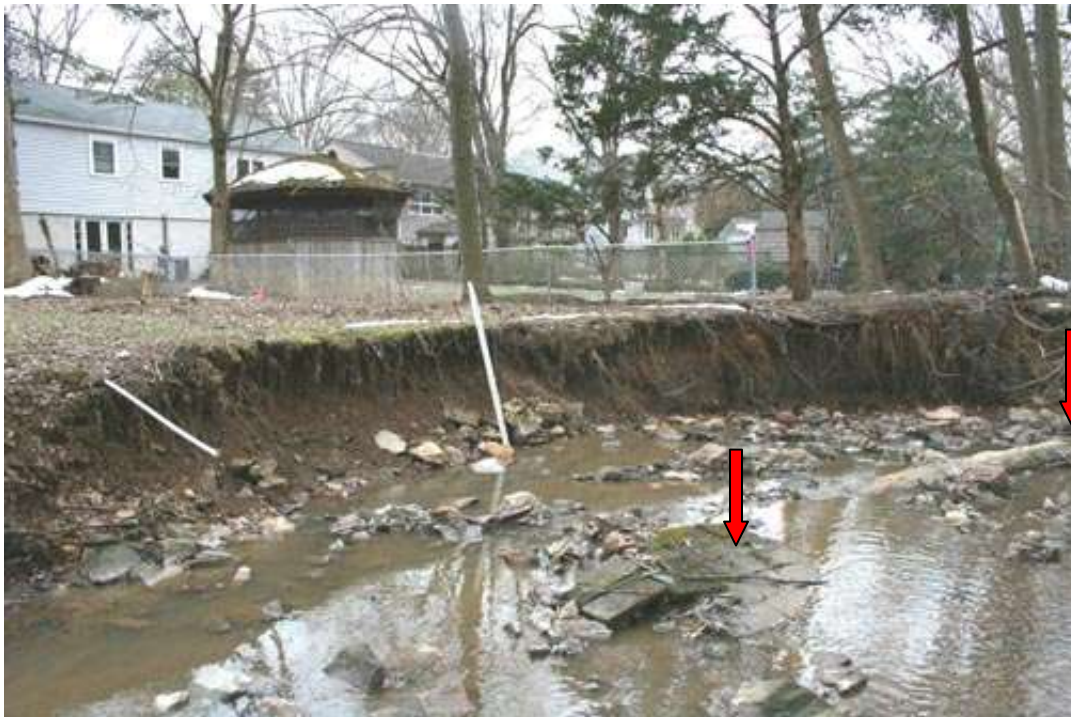
Fig. 36 (view downstream) – Erosion along left bank along lower middle section of reach; note remnants of cinder block retaining wall (red arrows).

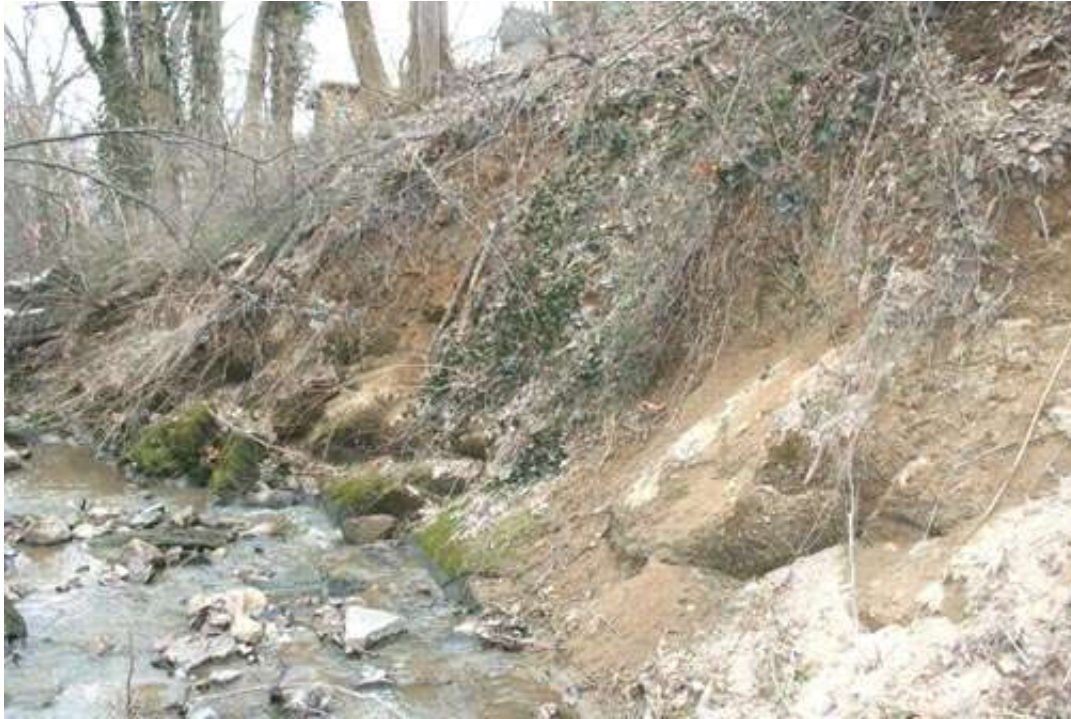
Fig. 37 (view downstream)– Bedrock exposed by scour along toe of high terrace on right bank.

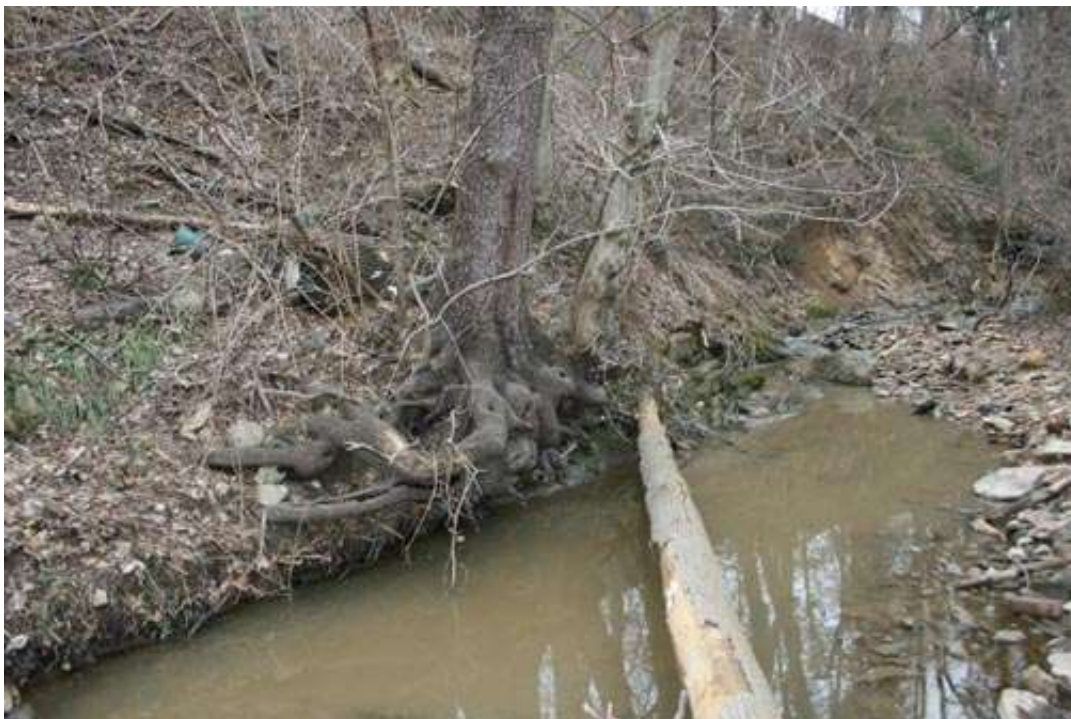
Fig. 38 (view upstream) – Undercut tree (Pignut Hickory) along right bank.

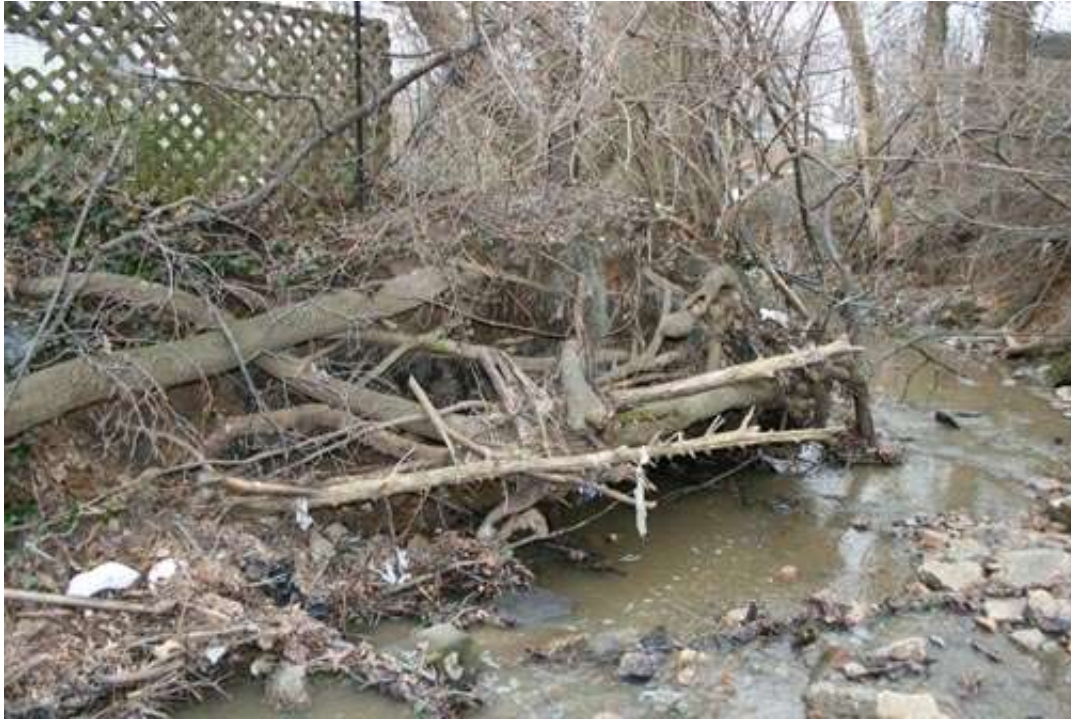
Fig. 39 (view downstream) – Severely undercut tree (Green Ash) along left bank.

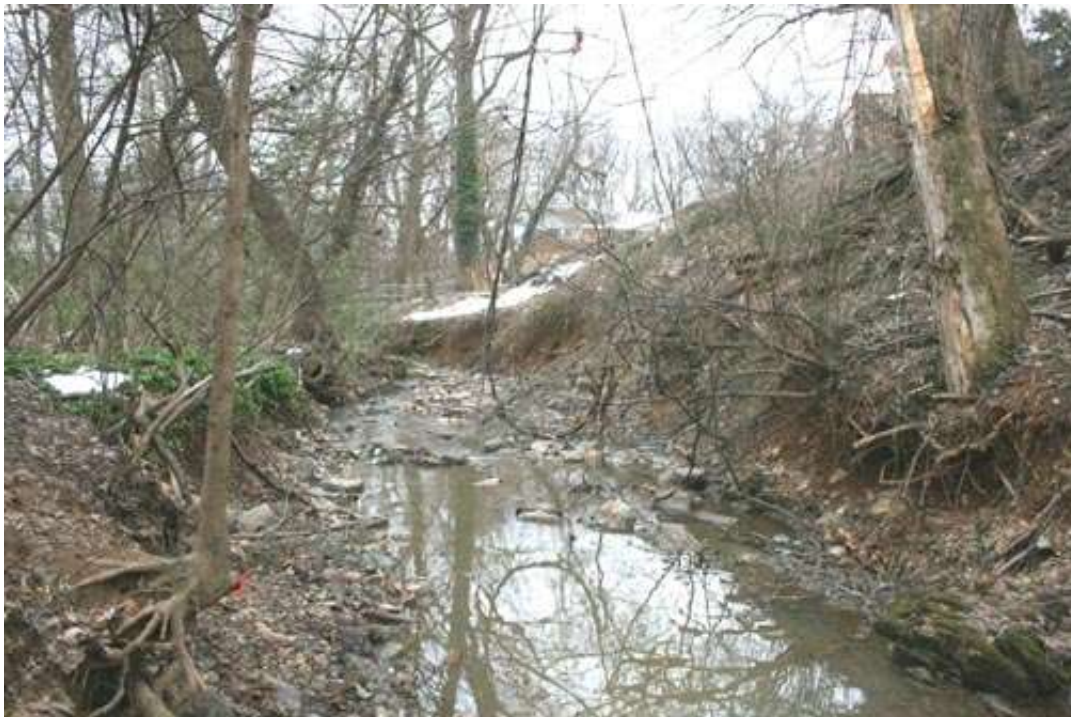
Fig. 40 (view downstream) – Bank erosion and undercut tree along right side of channel.

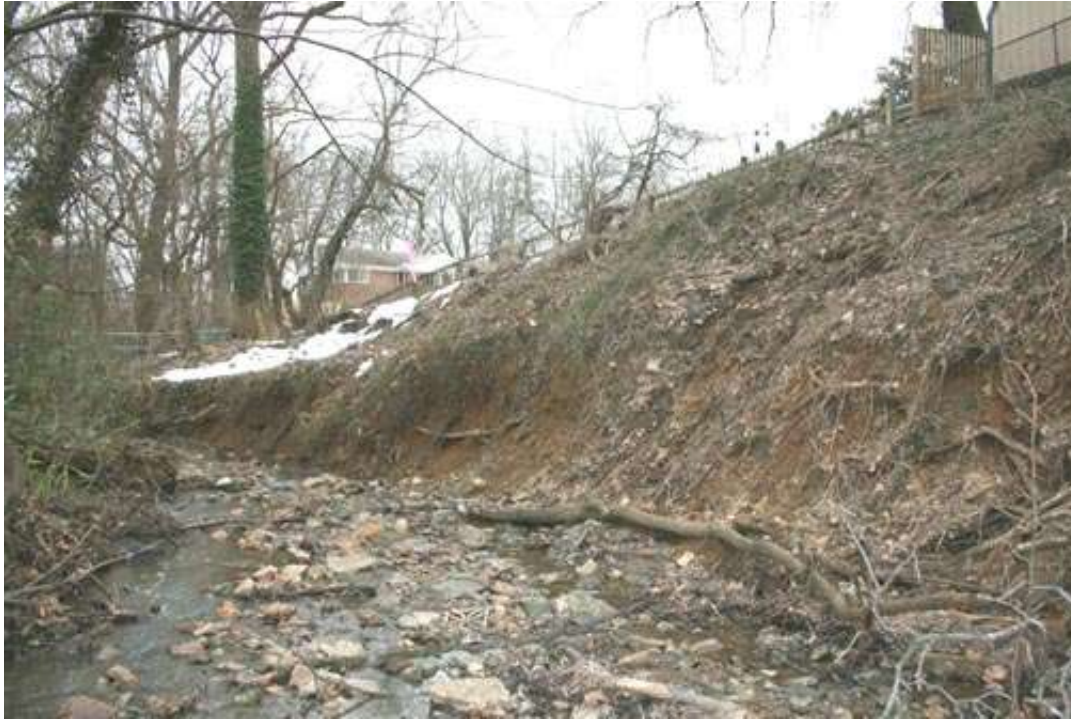
Fig. 41 (view downstream) – Erosion along right bank in lower section of reach.

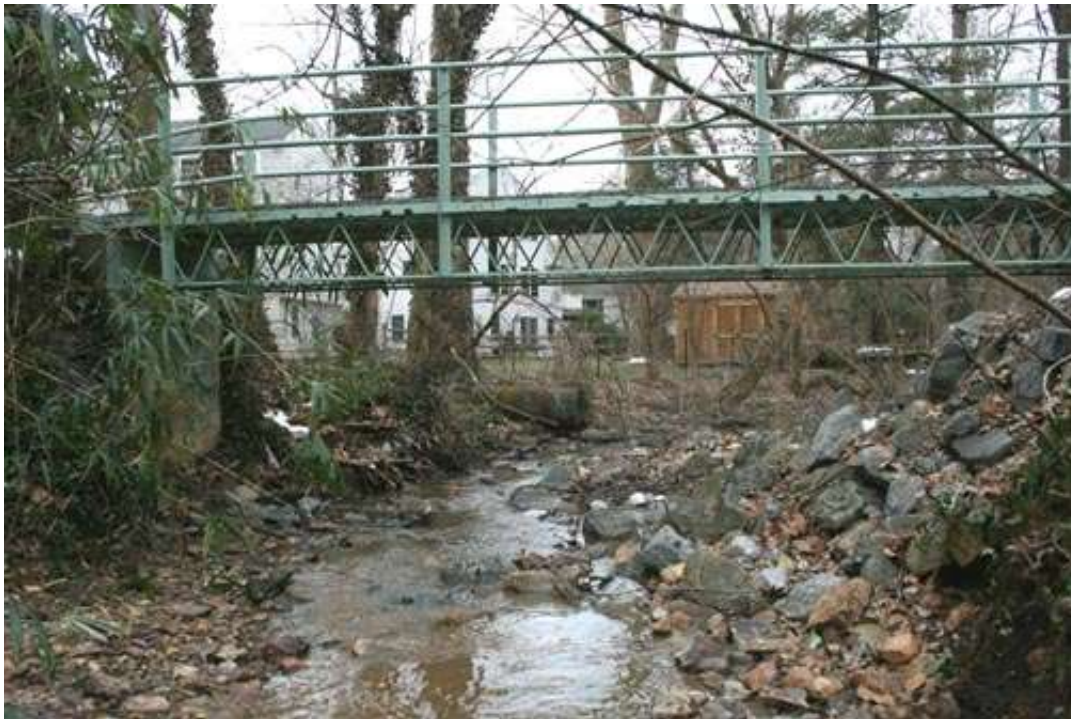
Fig. 42 (view downstream) – Spencer Road Footbridge at downstream end of reach.

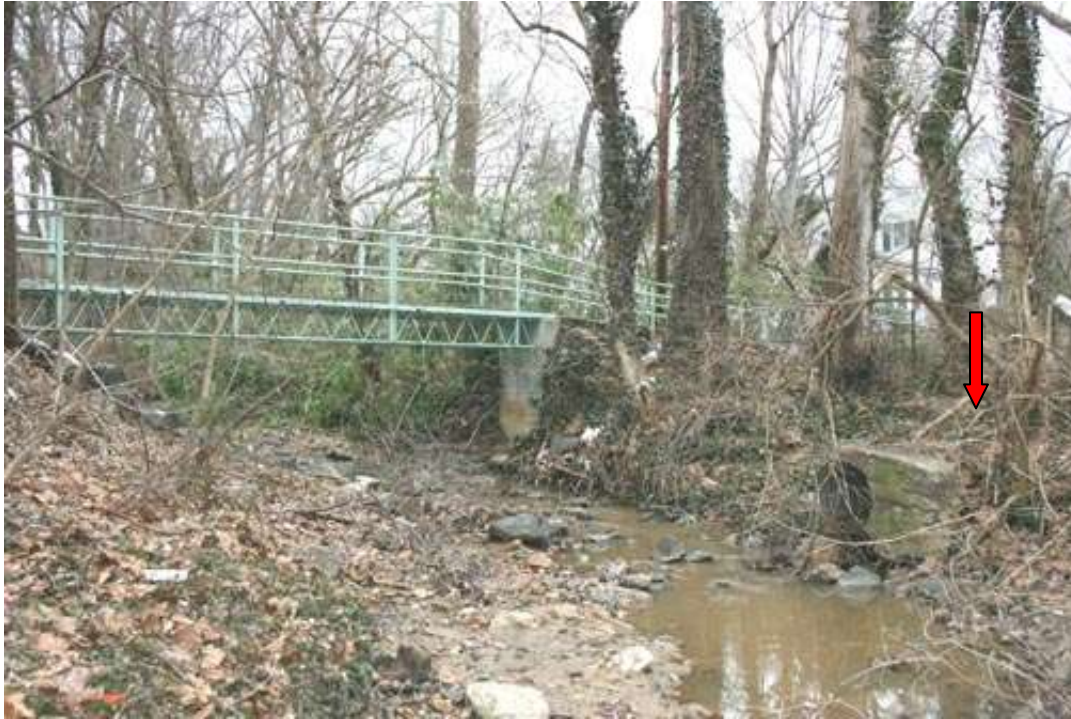
Fig. 43 (view upstream) – Start of reach with storm drain outfall along left bank (red arrow).

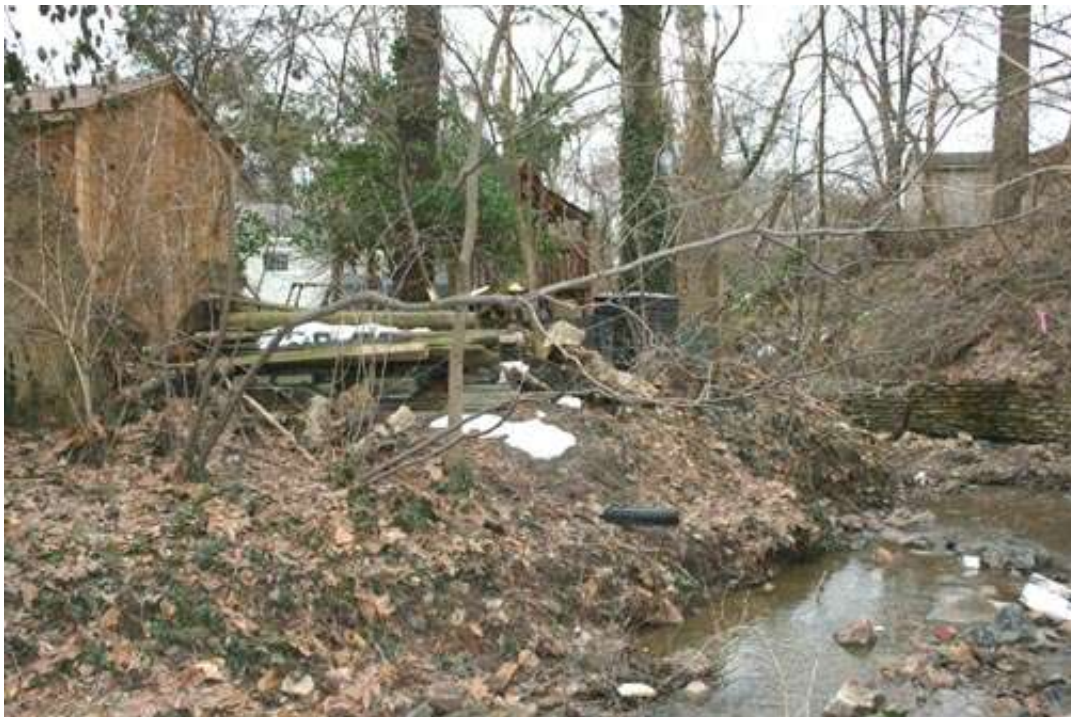
Fig. 44 (view downstream) – Sheds immediately adjacent to channel on left bank.

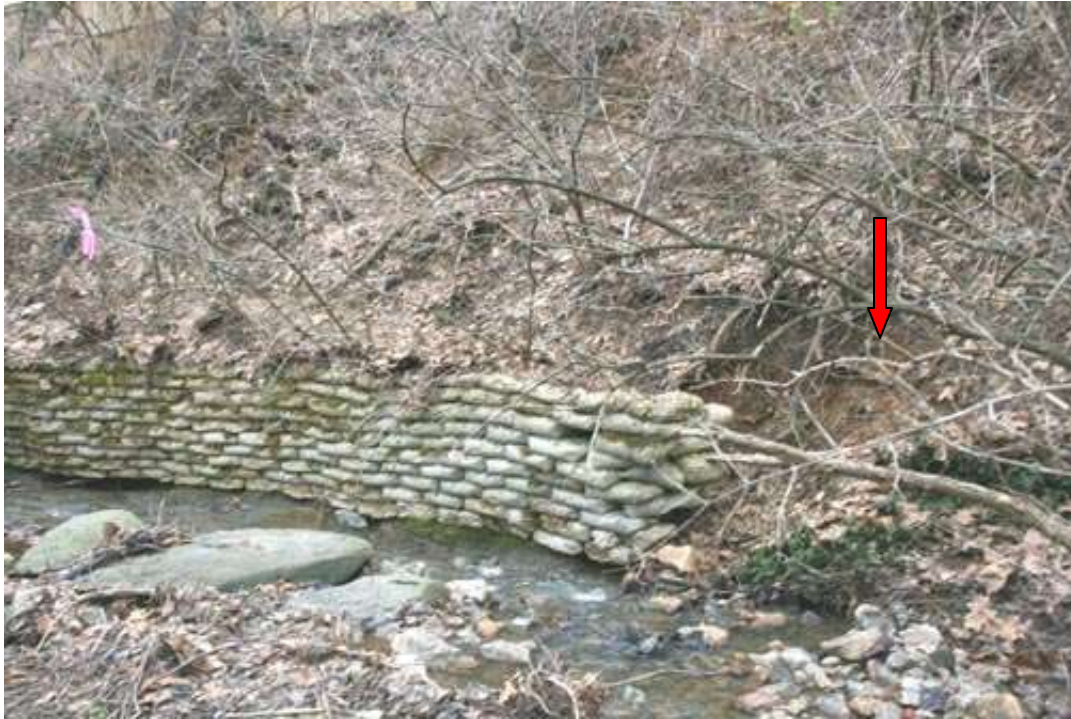
Fig. 45 (view downstream) – Erosion (red arrow) along toe of high terrace on right bank at upstream end of concrete sandbag wall.

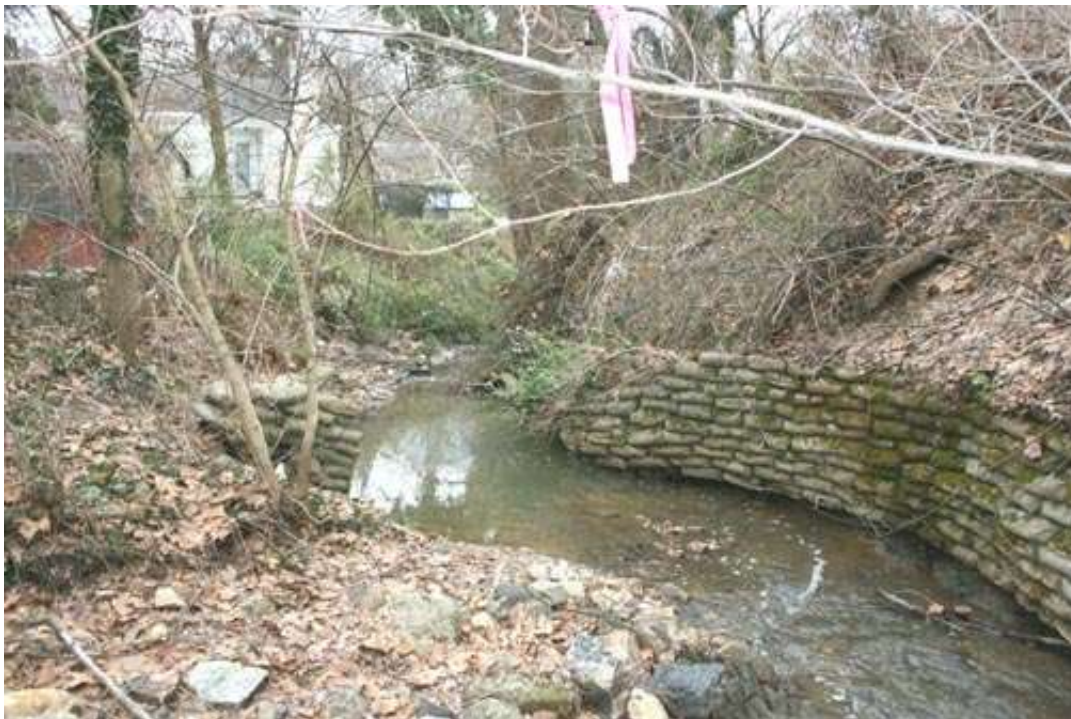
Fig. 46 (view downstream) – Constriction created by concrete sandbag walls on both sides of channel.

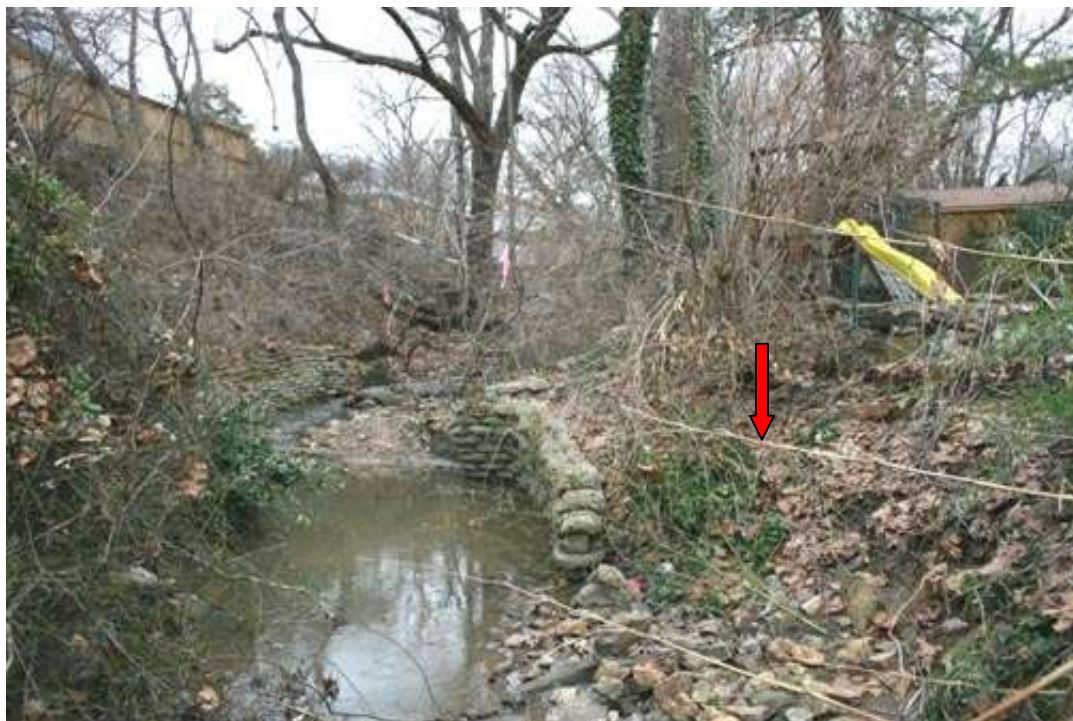
Fig. 47 (view upstream) – Scour behind concrete sandbag wall (red arrow) along left bank.
